Navajo Abandoned Uranium Mine

Site Screen Report

**Mine Name: Claim 3 / Claim 4
Mine ID: 805**

August 2011

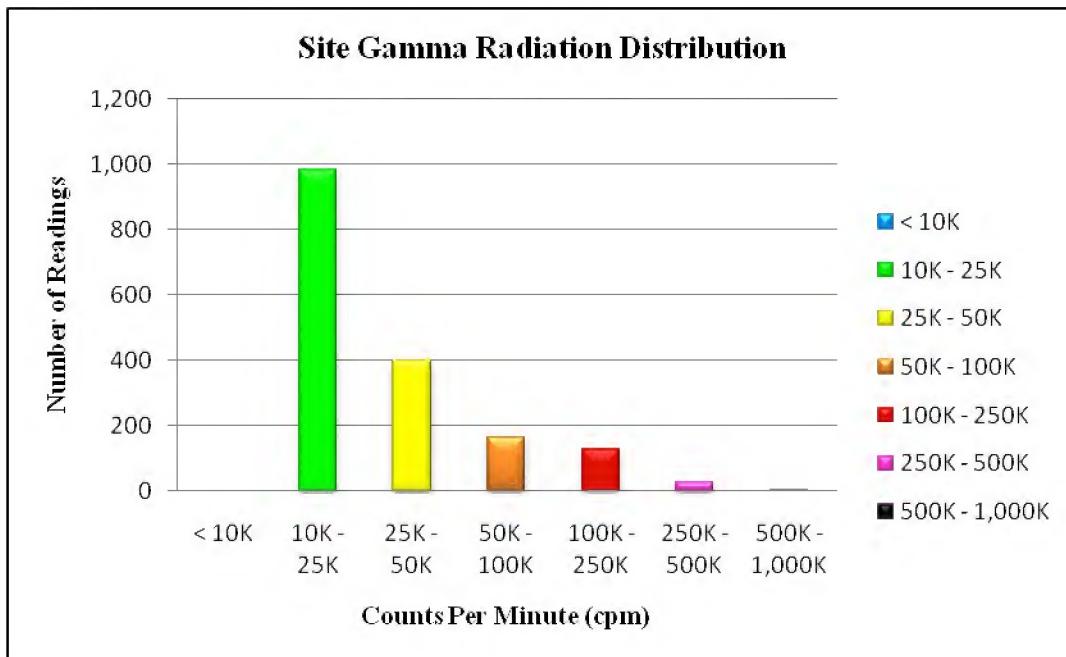
Highest gamma radiation measurement: 581,498 counts per minute (cpm)

Background Average: 15,706 cpm **Two Times Background:** 31,412 cpm

A total of 1,701 gamma radiation measurements were collected from the mine site, ranging from 11,382 cpm to 581,498 cpm. Measurements collected in the vicinity of the reclamation area were found at a maximum level of approximately 15,000 cpm. The measurements are represented in Figures 1 and 2.
